Heather Gregory: Investigation of a Slow-Moving Landslide: Hunter's Crossing Subdivision Waynesville, NC

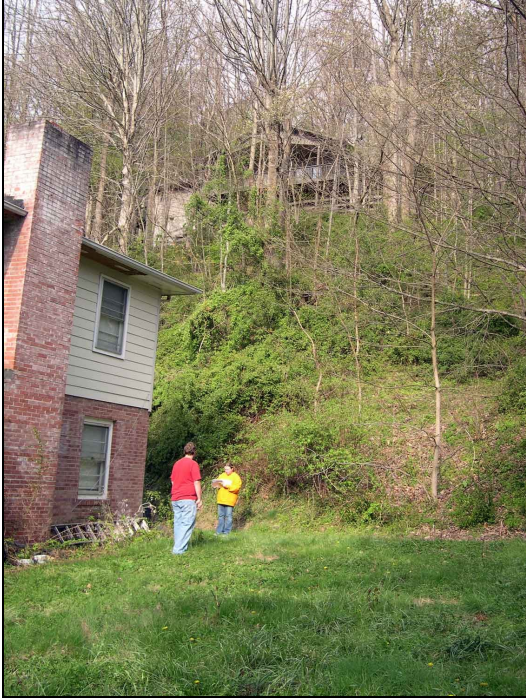
A brief timeline of the events that took place at the Hunter's Crossing community reveal that the slope has been moving for a longer time than when the residents first noticed damage to their houses and property. Starting from the 1950's to the 1970's, the toe of the slope was either eroded or was cut for the construction of the Lickstone residences. It shows signs of both. Figure 2 shows the toe of the slope, which is very steep, with one of the Hunters Crossing residences on the slope.

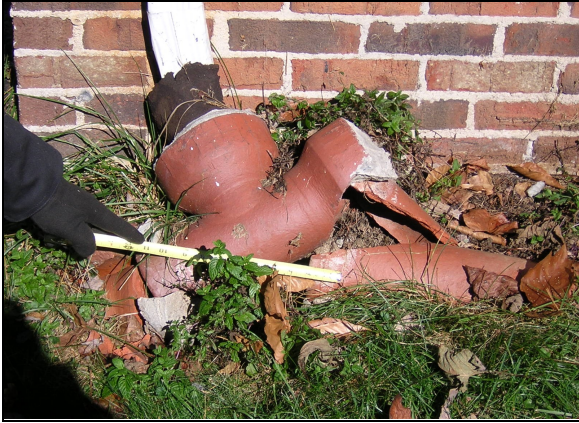
In 2001, the Hunter's Crossing community was constructed. In 2003, the first waterline ruptured due to the movement of the slope. In 2004, hurricanes Ivan and Frances swept through the area and dropped approximately 11 inches of rain on the area over 10 days. In 2005 the first damage was noticed and reported by the Hunter's Crossing residents. The second waterline rupture occurred, causing the water record to jump to 25,600 gallons. This is a large amount of water to be pumped into the sediments, possibly causing more instability, but that is unable to be proven at this time. The town of Waynesville shut off the utilities to the residences and forced the residents to vacate their properties. Figure 3 shows a sheared waterline at the toe of the slope and figure 4 shows damage to the foundation of a residence on the slope. Figure 5 shows damage to a carport on the slope, where the slope has pushed the carport so that it is leaning at an angle, and the beam has now become detached from the roof.

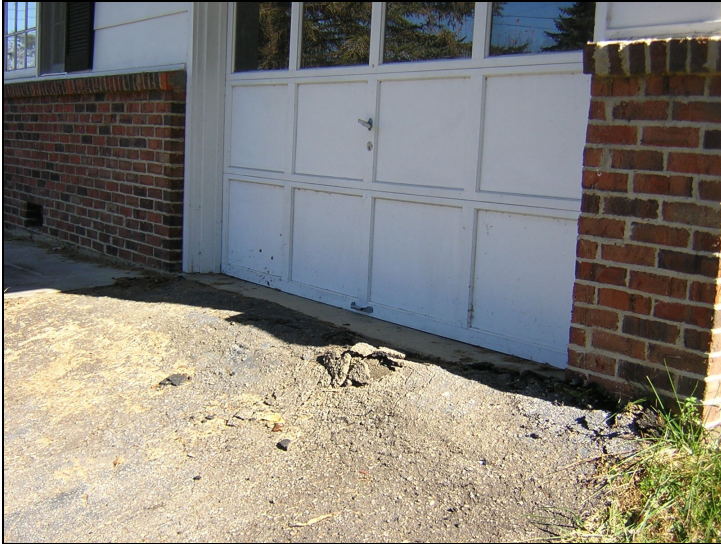
Figure 6 shows a buckled driveway at the toe of the slope due to the contractional movement of the toe of the slope.

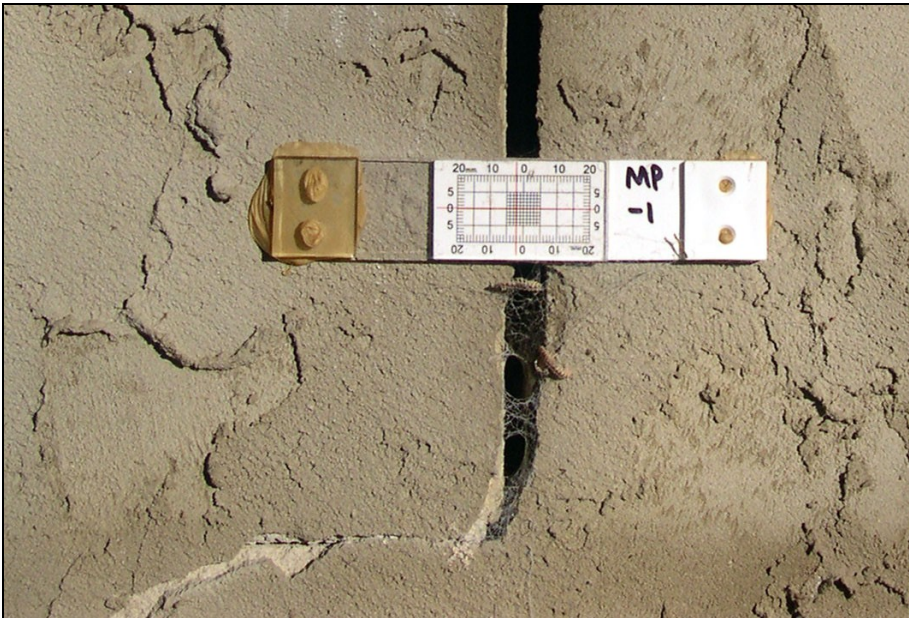
From August of 2005 to March of 2006, NCGS monitored the site and Alpha collected their data. Figure 7 shows a crack monitor installed by Alpha, where the amount of deformation can be seen by how far the red line has been pulled away from the 0 line.

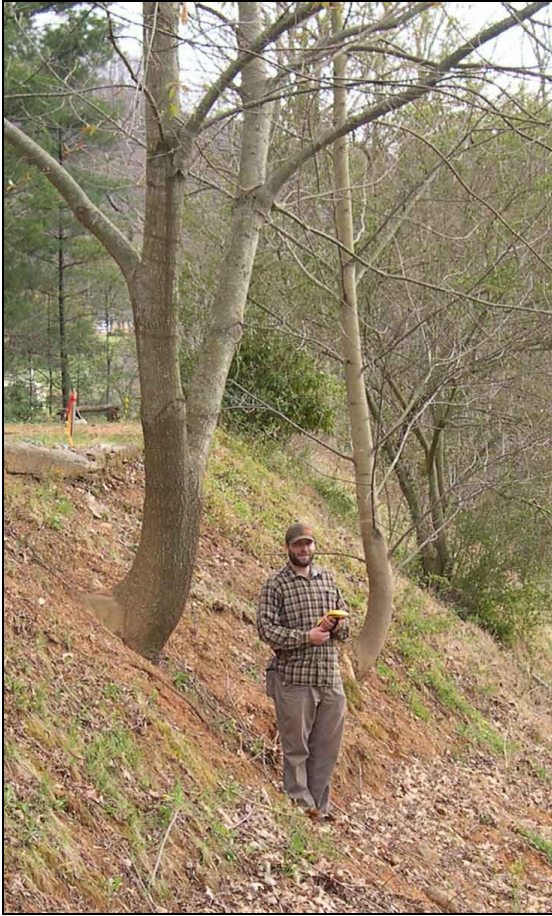
Figure 8 shows some of the curved trees on the slope. (Alpha) December, 2006, North Carolina Geological Survey

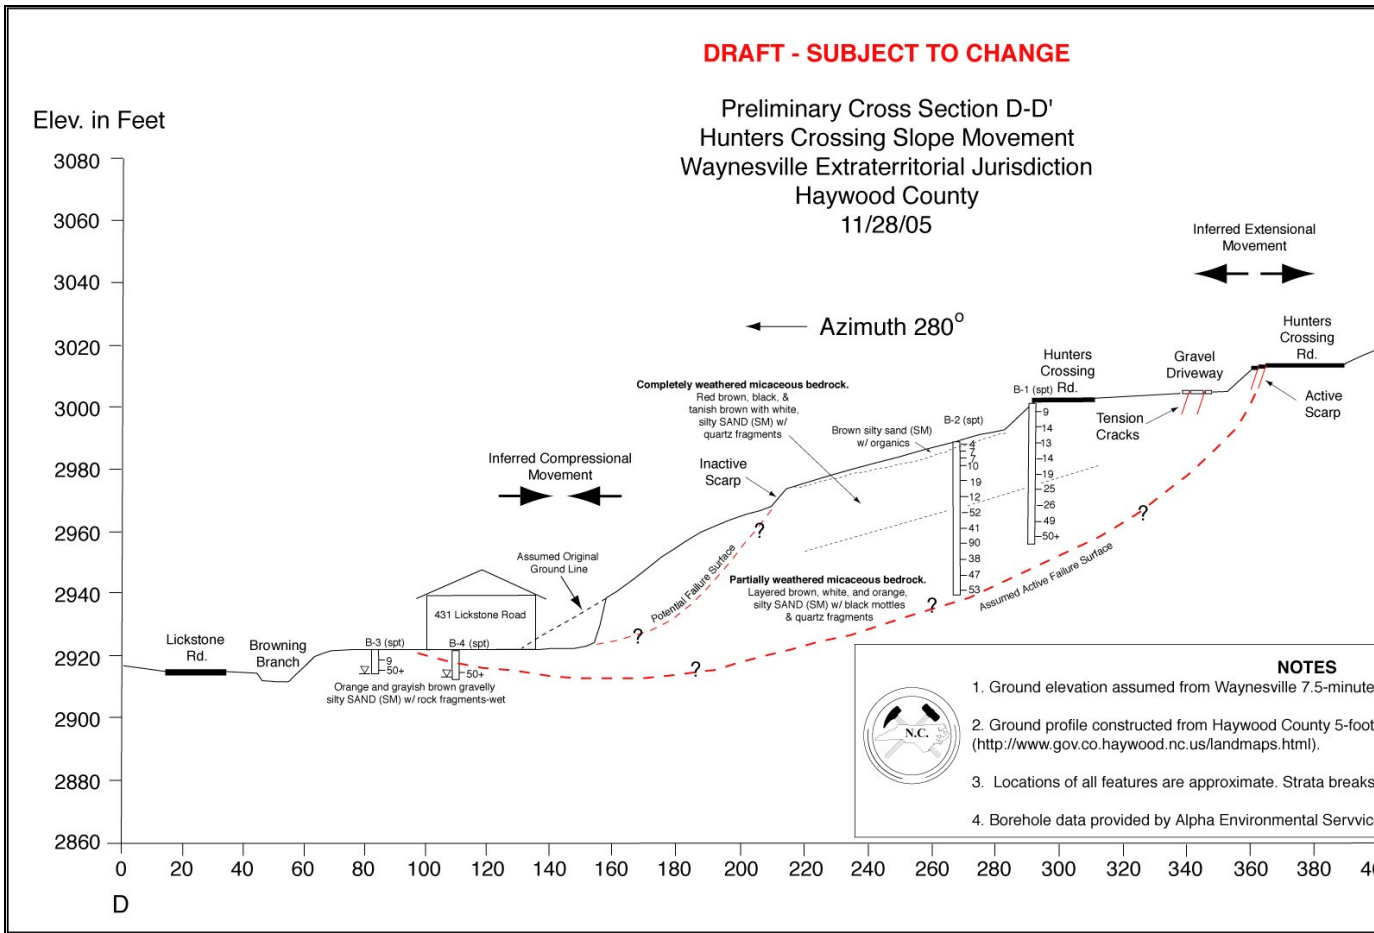
Figure 11

Alpha drilled four bore holes, where they took the sediment samples from them and analyzed them for their properties. Bore holes B-3 and B-4 were on the floodplain near Allen's Creek and bore holes B-1 and B-2 were on the slope. At no point did they encounter bedrock or the groundwater table. This led them to determine that the failure surface was greater than the depth of their deepest bore hole at around 53 feet. They provided a cross section that interpreted their assumptions about the depth of the failure surface and where it was believed to propagate, as shown in figure 11. Also shown in figure 11 is a possible failure surface at around 35 feet, which is mentioned in depth later.

The bore holes provided a basis for determining the instability of the slope. The properties of the soils were mainly micaceous silty sands, and sandy sediments are less stable to build. This is primarily because sand is permeable, and during a storm event the rain could increase the pore pressure in the sediment, leading to more unstable conditions and possible failure of the surface. With the sediment that Alpha Environmental Services, Inc. analyzed being very sandy, that would result in the slope being less stable. Figure 12 illustrates the results of Alpha's bore hole samples. Note that the only possible failure surface is recorded in bore holes B-1 and B-2 at approximately 35 feet, in which there is an abrupt change in sediments, going from micaceous to non-micaceous sediment. This could be a possible failure surface because the sediment could be less permeable which

could cause water to pool on the surface, creating a failure surface. At this time, this is the only possible failure surface that has been identified. (Alpha) December, 2006, North Carolina Geological Survey

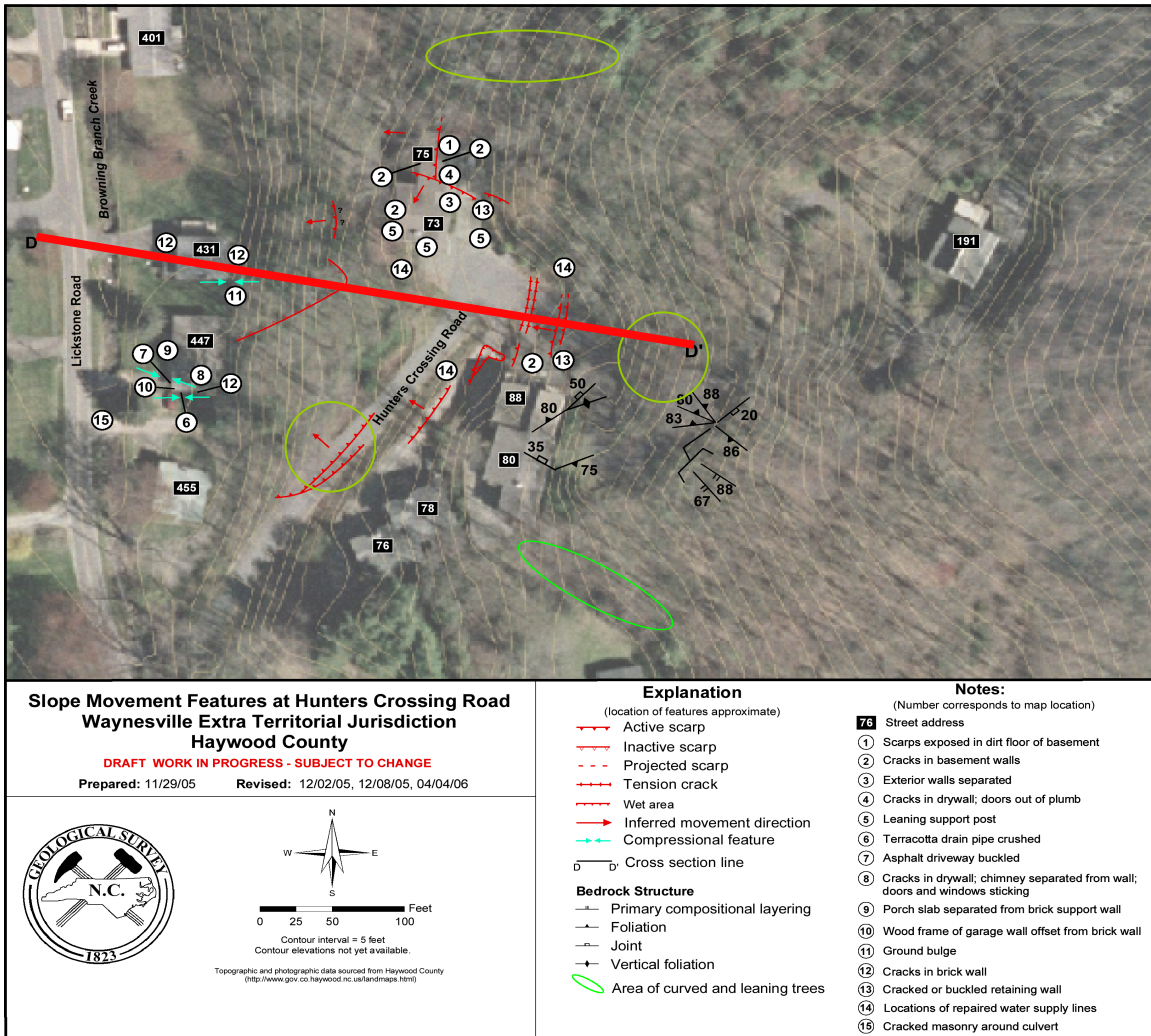
Figure 13

A further analysis of the scarps that the NCGS mapped provided more evidence for slope movement. A cross section was put together by the NCGS showing where some of the scarps are located, as shown in red in figure 13. The areas of trees that the capstone researchers mapped out are shown in olive green, while the area that the NCGS mapped

is shown in brighter green. The cross sectional line is shown in bright red. The blue arrows refer to compressional features.

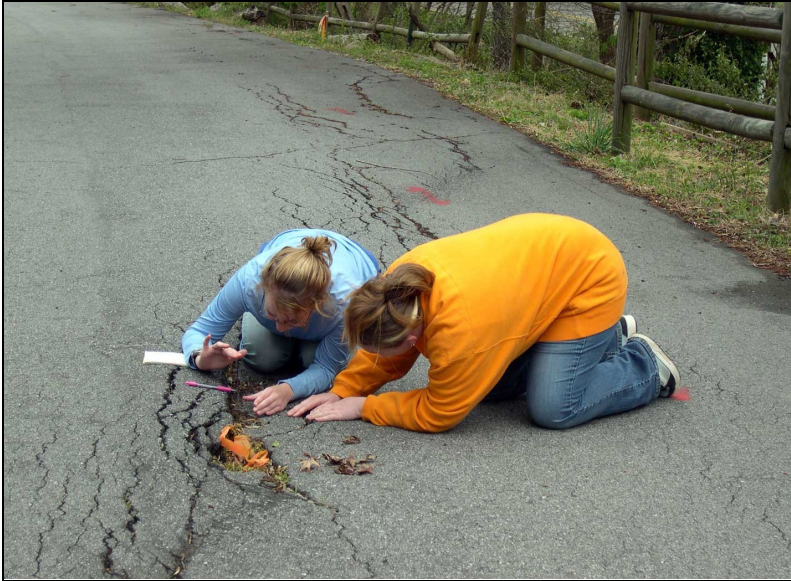
Figure 14

Figures 14 provides a close look at the measurement of the scarp 8, and figure 15 provides a close look at the measurement of the head scarp.

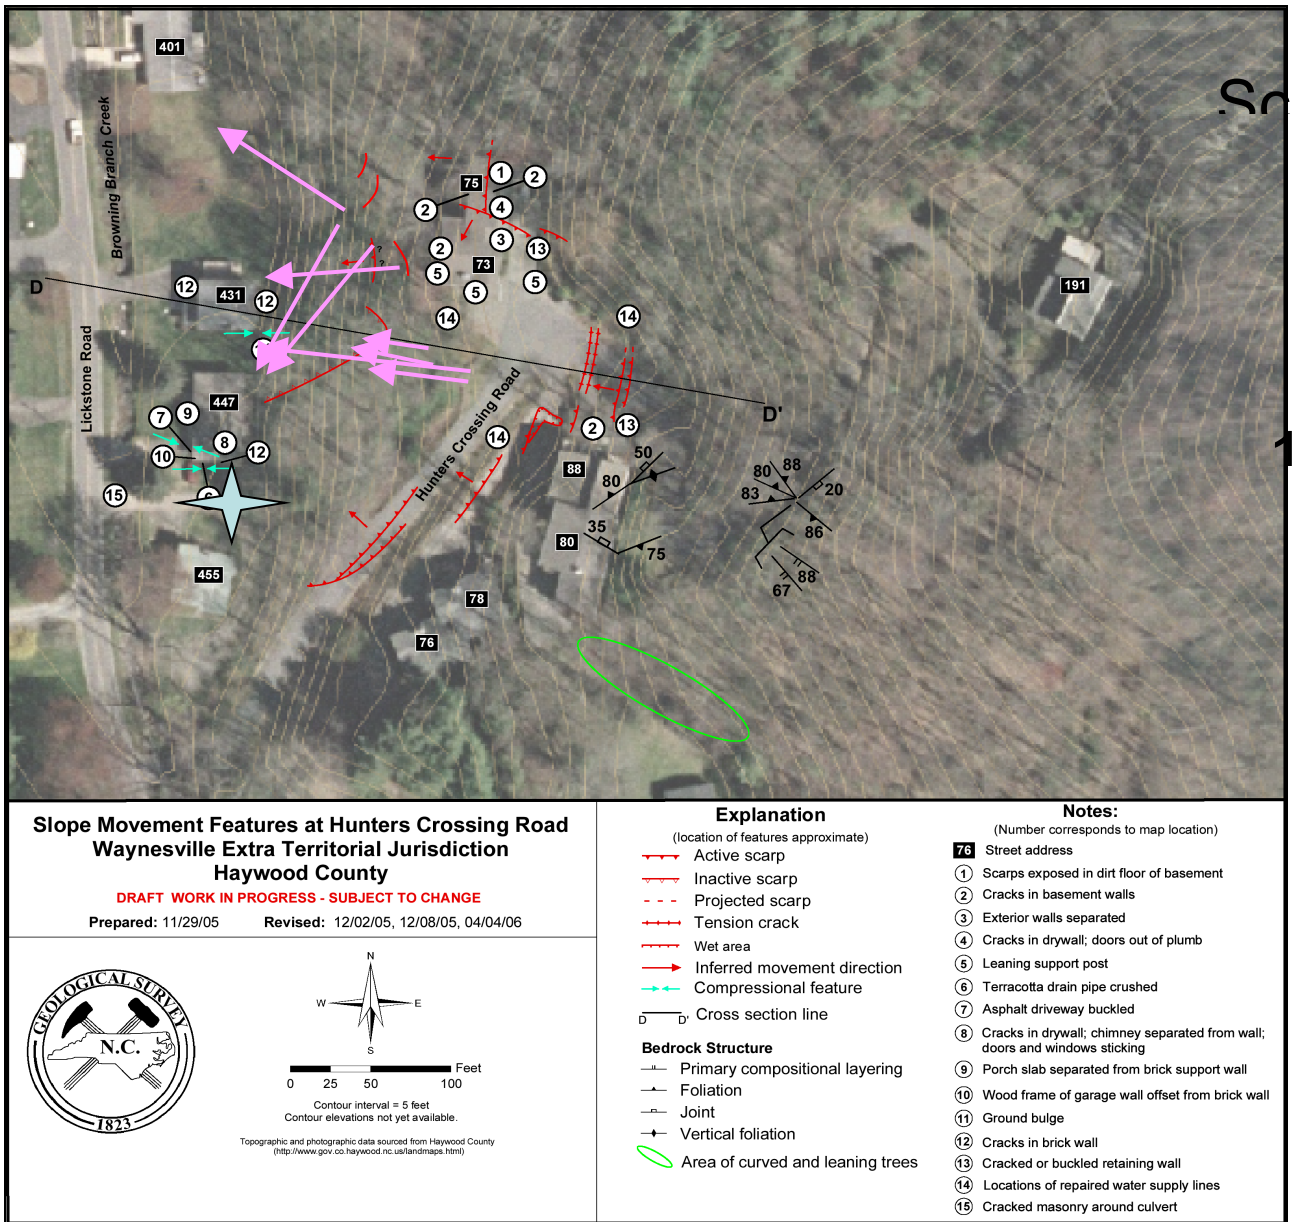
The movement of the scarps was recorded by measuring the horizontal and vertical displacement of the cracks, wherein the direction of movement was determined using a

Brunton compass. Figure 16 is an illustration of the direction and amount of movement of the scarp cracks, on a 1:4 scale.

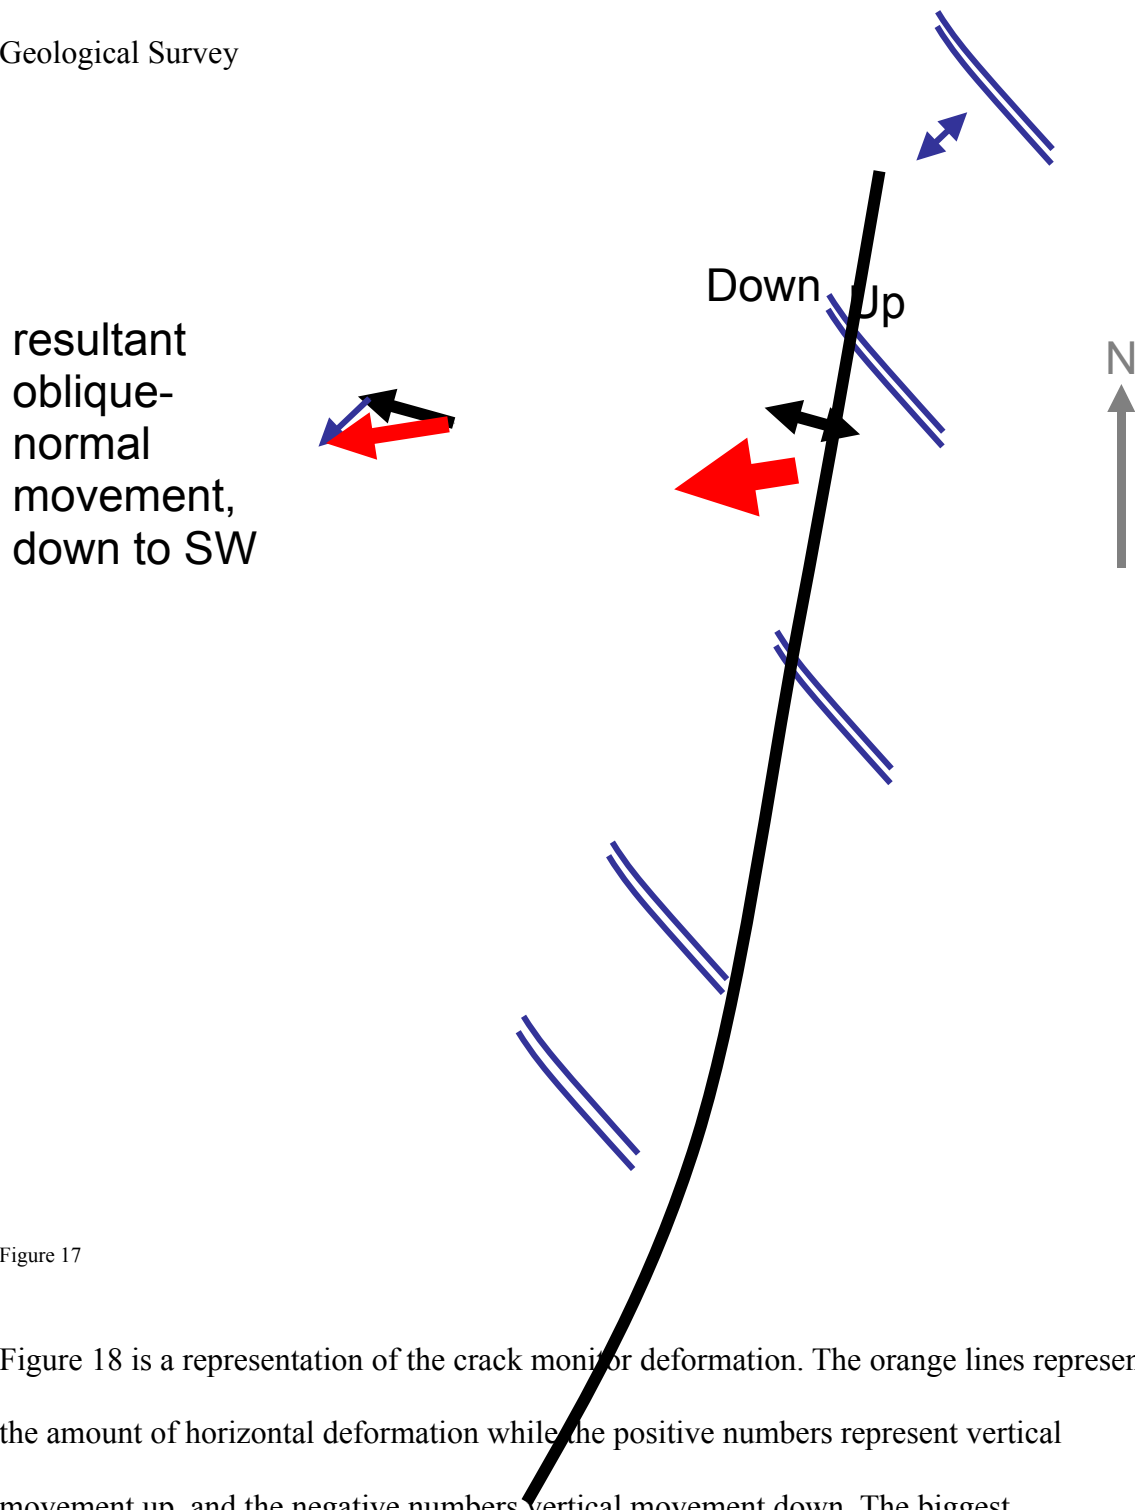
Figure 17

Scarp 8 is shown in more detail in figure 17. Scarp 8 is behaving as a normal fault would, with the Down side being the hanging wall and the Up side the foot wall. The black line is the normal fault while the blue lines are secondary extensional fractures due to the oblique movement of the fault. The large red arrow indicated the direction of the oblique

movement, which is to the southwest. (Alpha) December, 2006, North Carolina
Geological Survey

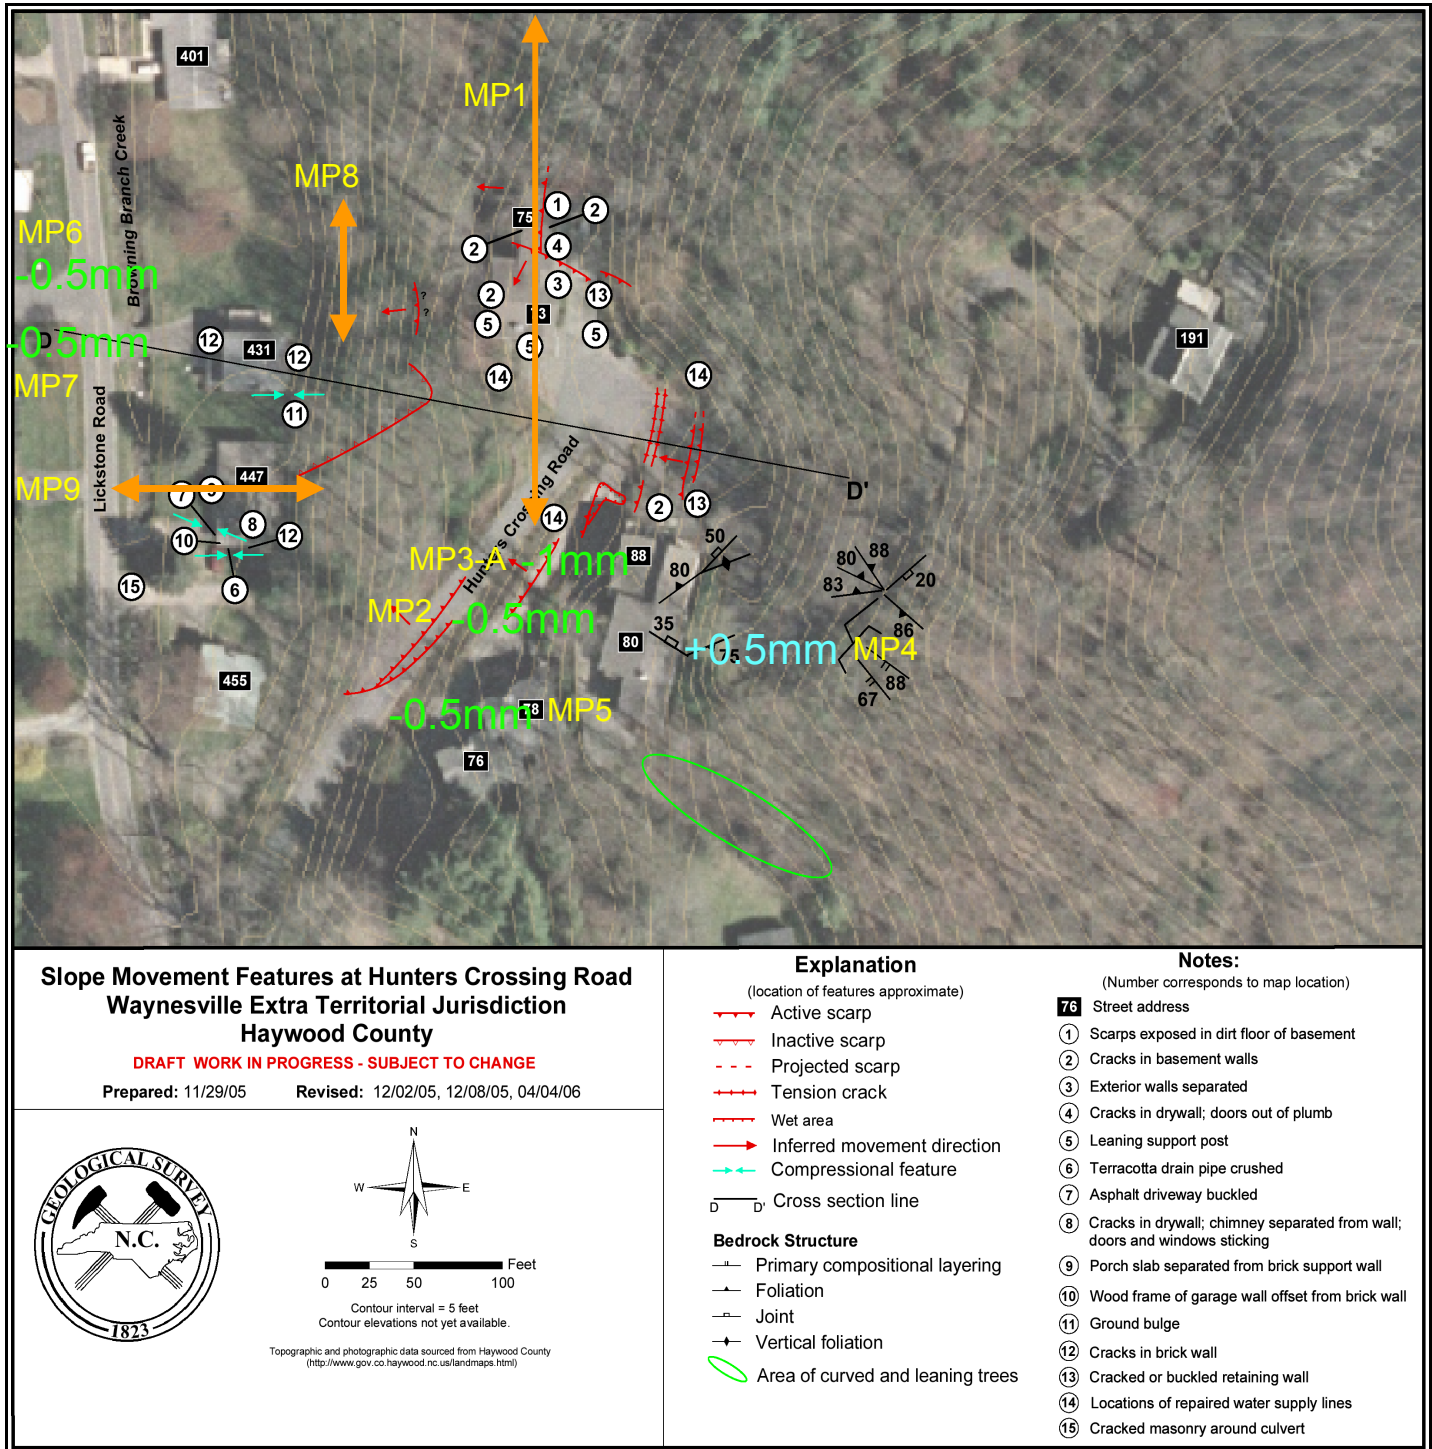
Figure 18 is a representation of the crack monitor deformation. The orange lines represent the amount of horizontal deformation while the positive numbers represent vertical movement up, and the negative numbers vertical movement down. The biggest deformation took place at MP1 where the crack monitor recorded a horizontal displacement of 2mm. The most vertical displacement took place at 88 Hunter's

Crossing, where MP3-A, MP2, MP5, and MP4 are located. On the map, 1 inch is equal to 1mm of deformation. (Alpha) December, 2006, North Carolina Geological Survey

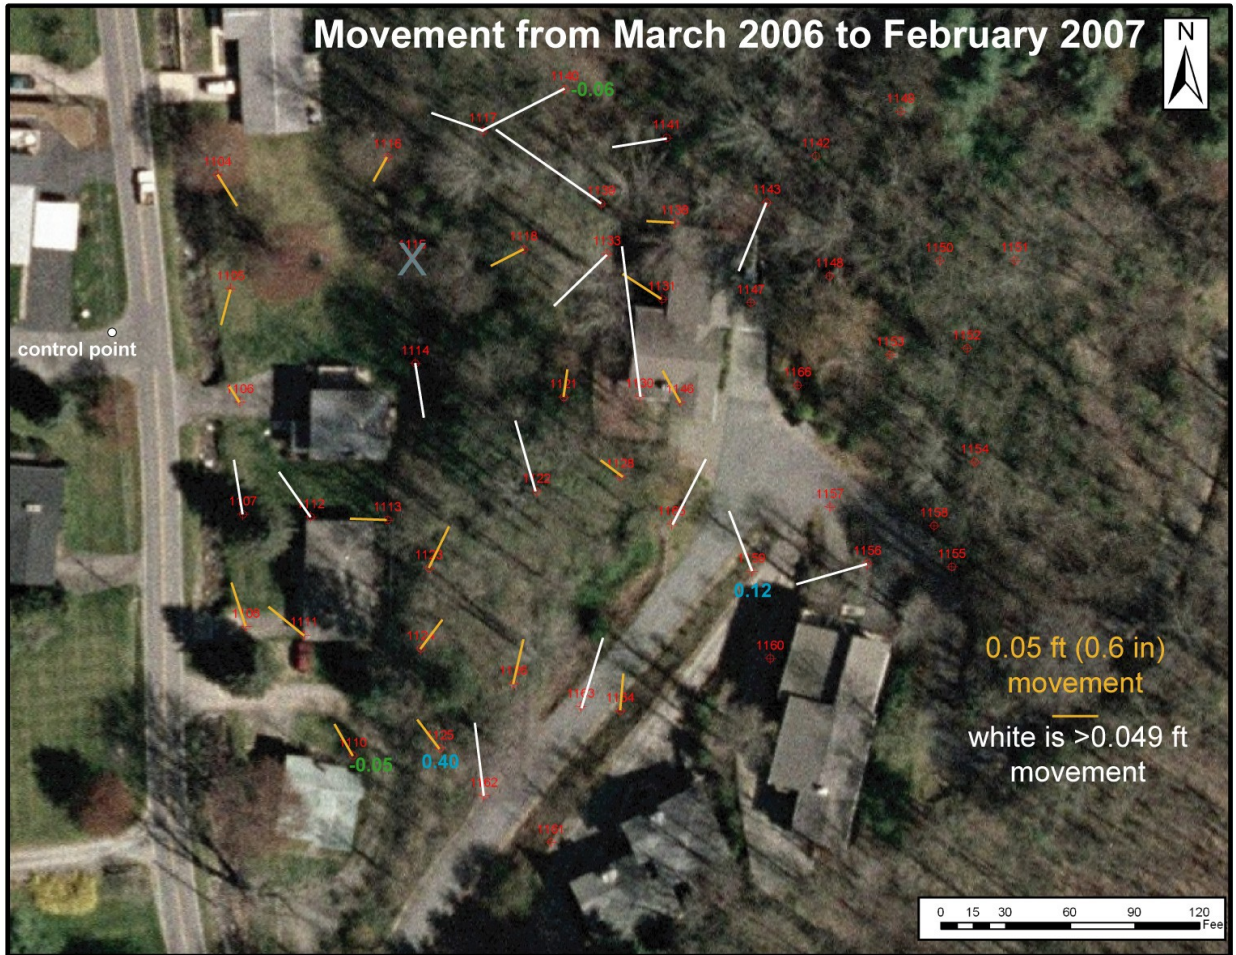
The total station data that was collected by Alpha was used as a base point for the capstone researchers to continue to monitor the site to determine if there had been any more movement. The vector map shows the results from the capstone researcher's results. The control point that Alpha had originally established was located on the other side of Lickstone road. But some of the points that they said were visible from the control point were not visible to the researchers. The white lines represent any significant movement greater than 0.05ft. 0.05ft was the margin of error calculated by the capstone researchers, so anything greater than that was considered to be significant. The orange lines represent possible significant movement. Not all points have vector lines on them because not all the movement was significant. The numbers represent any vertical movement that was significant. Figure 19 is a vector map of the capstone researchers' results.

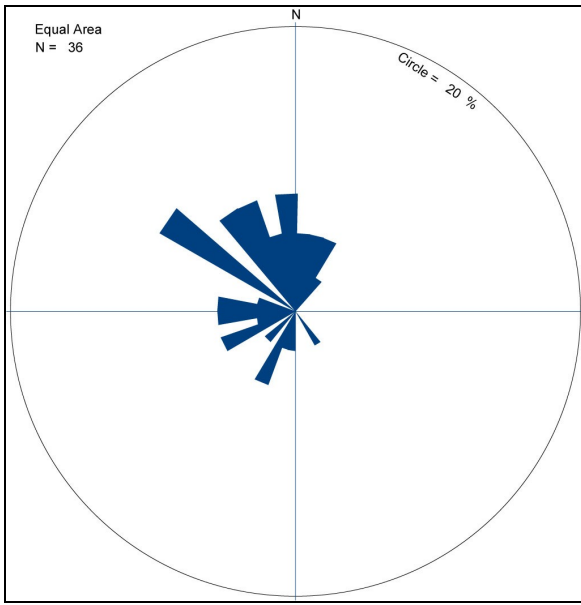
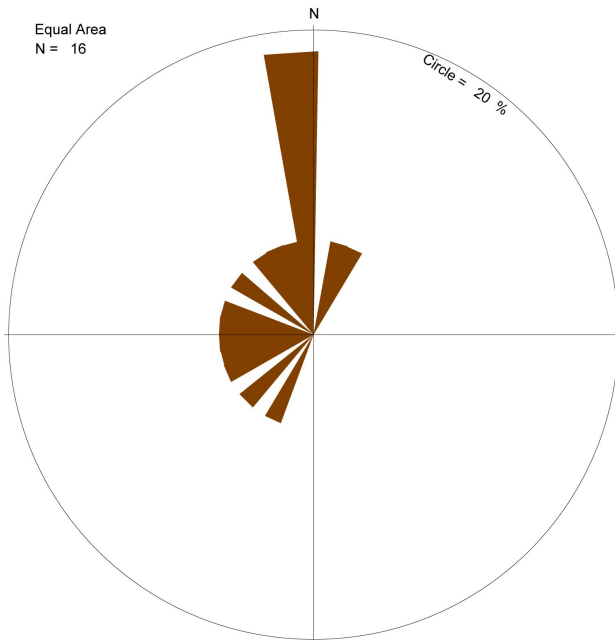
Figure 20 is showing Rose Diagrams, which are like bar graphs in 360 degrees. Each wedge shows the number of movements in a certain direction. The blue diagram shows all horizontal movements. The red diagram shows all significant movements. Most trend towards the N-NW. (Alpha) December, 2006, North Carolina Geological Survey

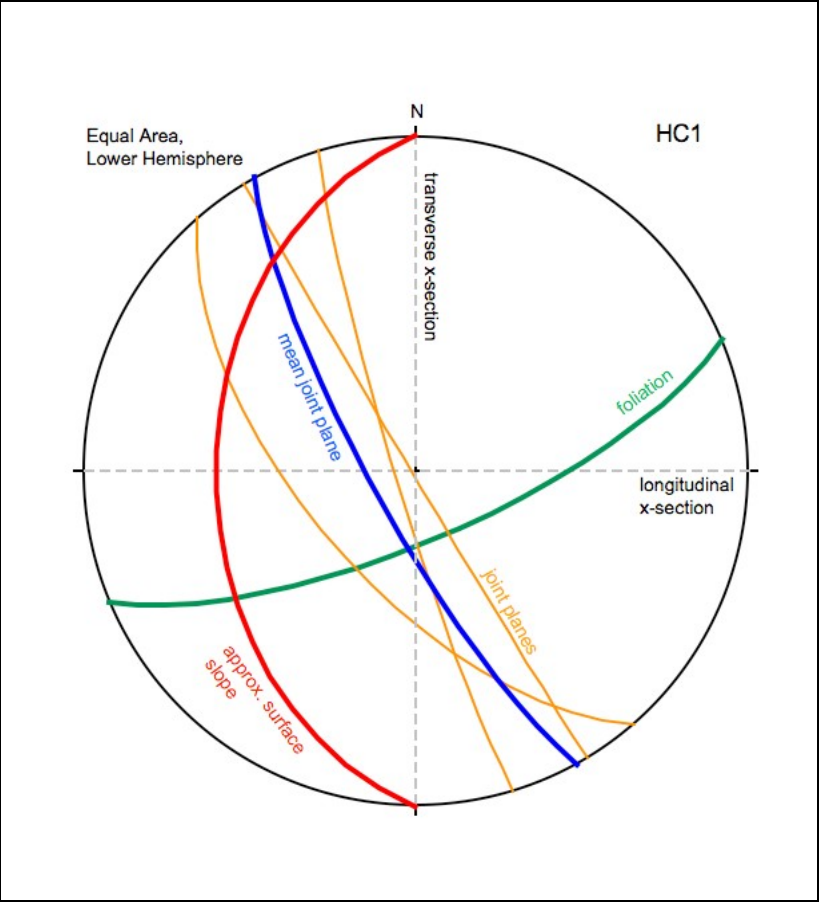
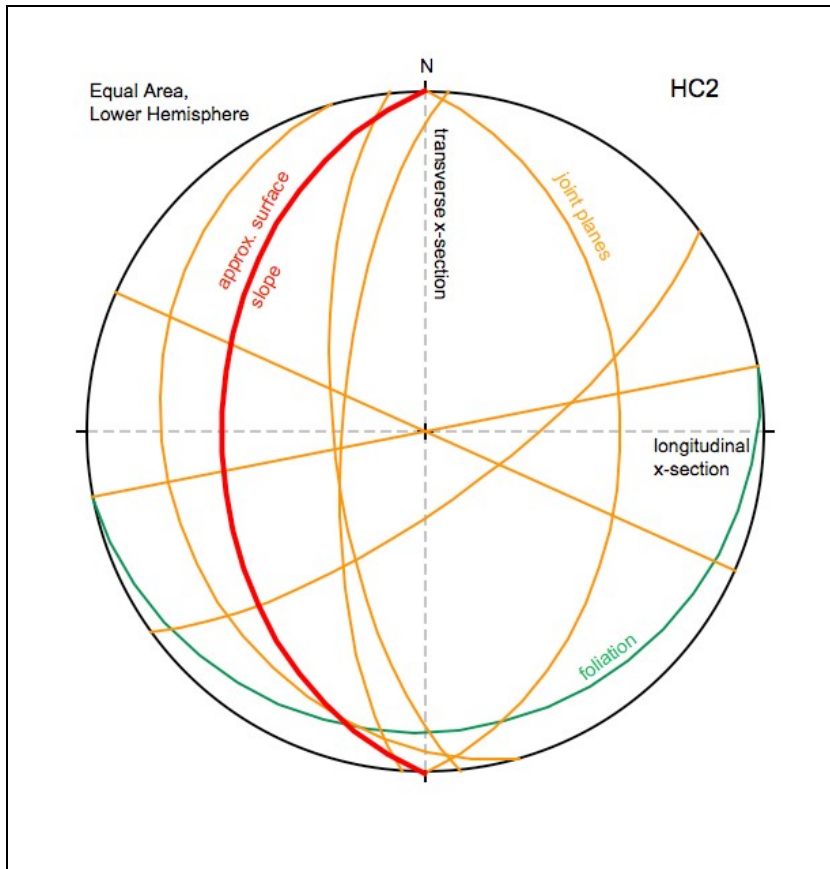
The strike and dip of joints and foliations of outcrops were taken on a hike up the Hunter's Crossing property. Stereonets were then completed using the information gathered from the hike. The stereonet provides information on the dip direction of the foliations, joints, and the slope surface. Figure 21 are the stereonet that were calculated. There are candidates for weak surfaces in the bedrock that could contribute to slope

instability. The most abundant joint sets seem to dip W-SW, which dip in the same direction as the Hunters Crossing land surface. Foliation dip would not contribute to slope instability unless it is forming part of a “chute”. Chutes provide a surface for sediment and water to travel through, making it unstable. (Alpha) December, 2006, North

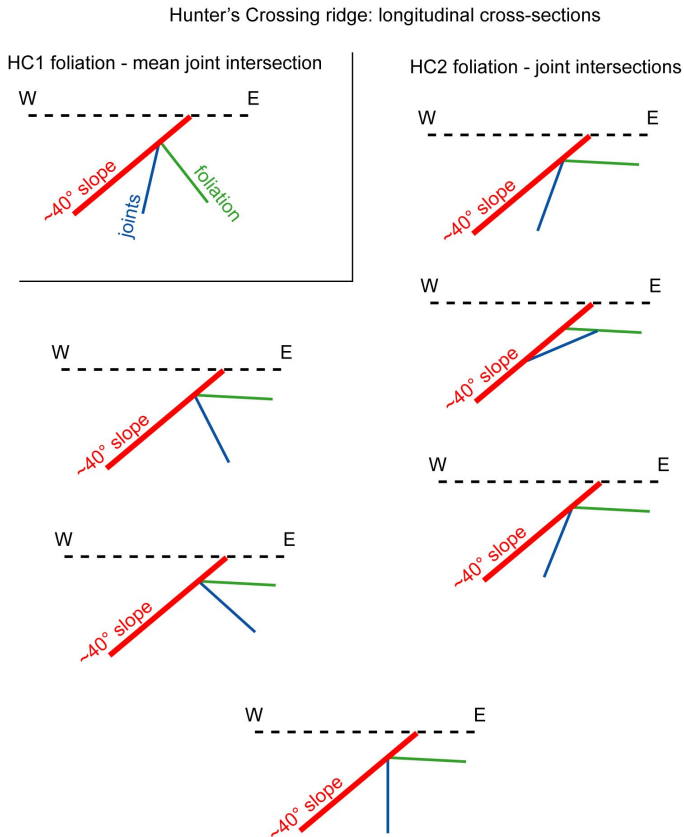
Figure 23 shows a representation of the joint and foliation intersections as if one was looking upslope to the north. Only one intersection could possibly be a chute, and that is the second intersection in the HC2 measurements. (Alpha) December, 2006, North Carolina Geological Survey

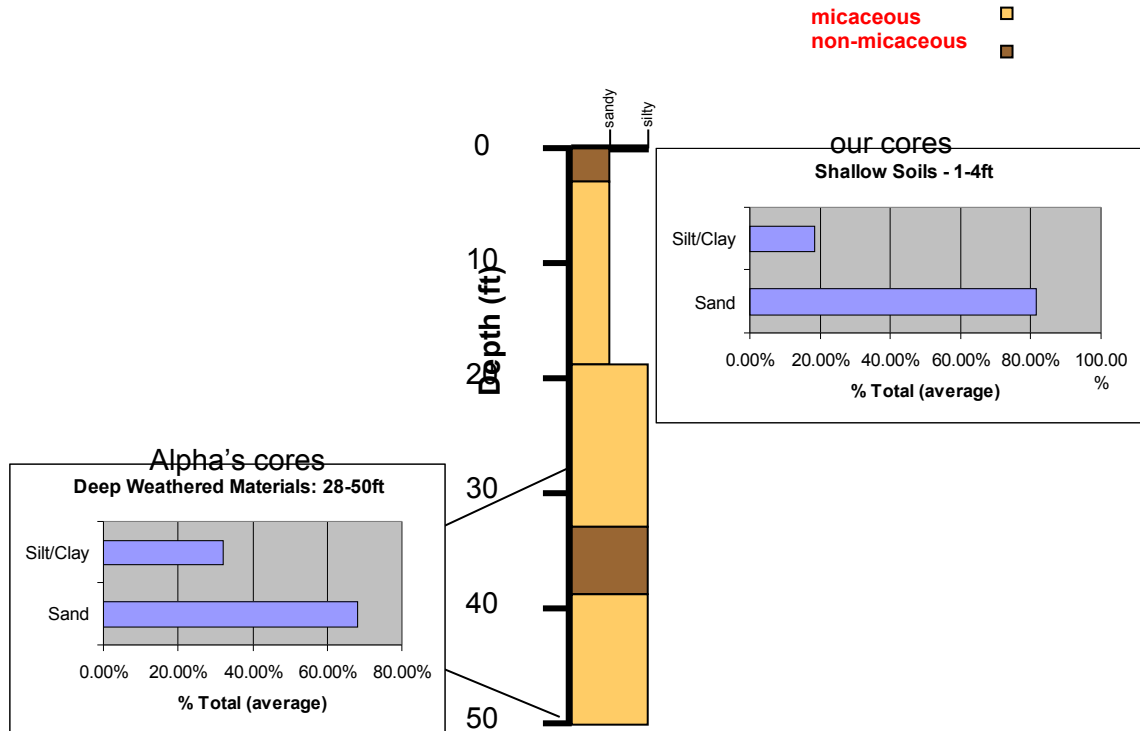
The analysis of the sediment size done by Alpha was done at 28-50ft deep and was almost 75% sandy materials. The cores taken by the capstone researchers was taken at a depth of 1-4ft and was nearly 82% sandy materials. The sediment analyzed by Alpha was all saprolite, while the first three feet of sediment analyzed by the capstone researchers was sediment, and then saprolite after about 3 feet. This is an extremely high amount of sand to be on the slope of a mountain, and is unstable to build on. This is an unusual feature of the area. The unconformity at around 35 feet of the non-micaceous silty sand is the only possibly failure surface that has been identified. There have been other “big slow movers” analyzed in North Carolina, and all show the same sandy sediment. Figure 24 shows a representation of Alpha’s results and the capstone researchers’ results. (Alpha) December, 2006, North Carolina Geological Survey

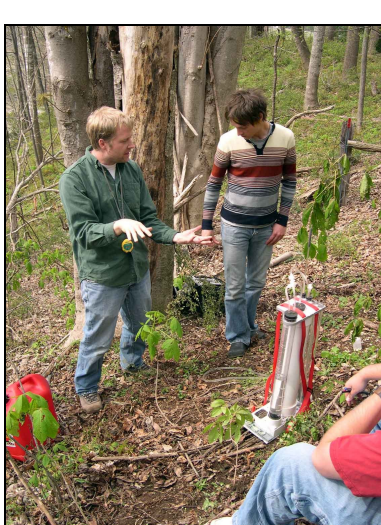
The area shows a relatively normal precipitation pattern, except in September of 2004 when hurricanes Ivan and Frances hit the area. The permeability of the sediment was measured, which was 1.1×10^{-3} cm/sec, which is comparable to sand-sized sediments.

Figure 25 shows a picture of the installation of the permeameter which measured the sediment permeability. (Alpha) December, 2006, North Carolina Geological Survey
