FACILITY COMPLIANCE AUDIT REPORT
Division of Waste Management
Solid Waste Section

Dates of Audit: 10/12/10

Haywood County Municipal Solid Waste Landfill
Francis Farm Road
Waynesville, N. C. 28786

Partial Audit

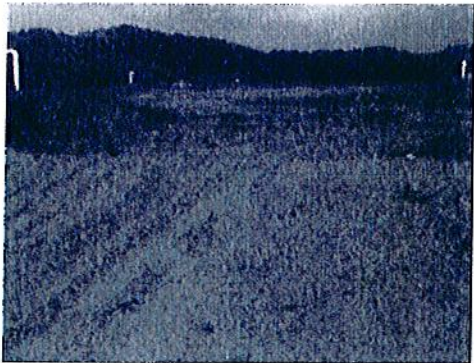
10/12/10

1. Partial audit inspection of closed MSWLF conducted by A. Keller and S. King as follow-up to the Notice of Violation issued on July 21, 2010.
2. The closed MSWLF cap appeared to be in good condition following the installation of landfill gas (LFG) vents and wells associated with gas extraction system. Further work will be required to fully establish vegetation on the areas disturbed during the installation event.

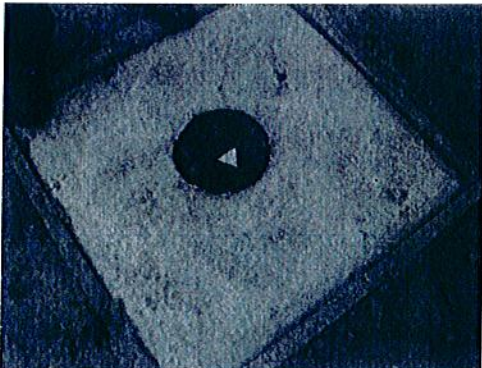
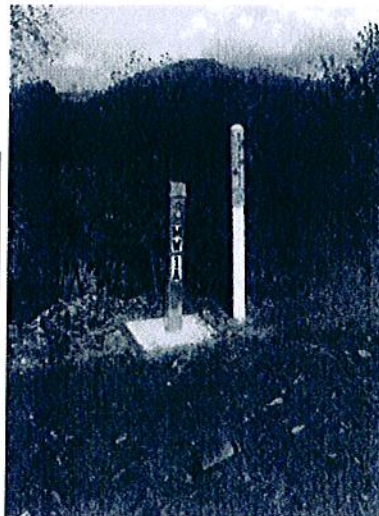
10/12/10

3. Groundwater monitoring well installation had been completed at the time of the audit (in accordance with the approved Groundwater Assessment Plan). Wellheads need to be locked and labeled (subcontractors still working on completing wellheads).

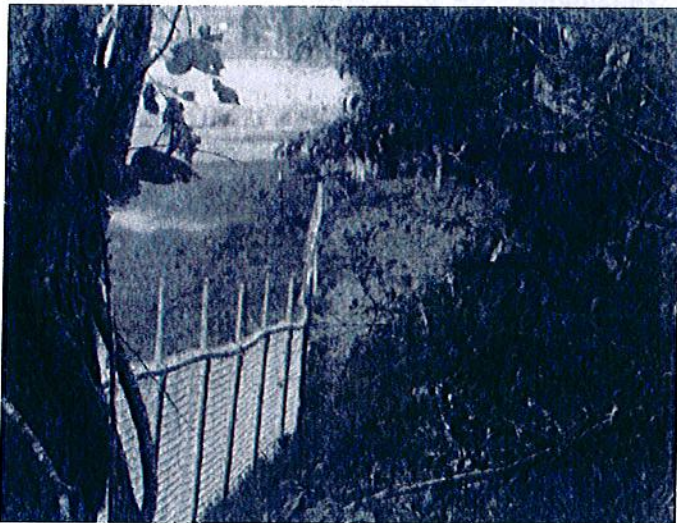
10/12/10

Newly installed MM-1, MM-2, and property boundary fence (northern edge of property).

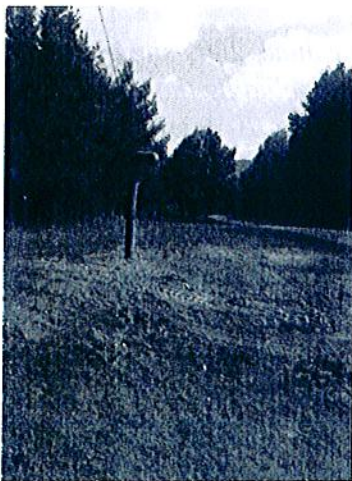
10/12/10

8. The landfill edge-of-waste (EOW) potentially extends beyond what current site maps indicated (per conversations between A. Keller and J. Bishop, and A. Keller and S. King). Further document review and site investigation was conducted and the investigation was ongoing at the time of the inspection.

As part of the LFG mitigation activities at the facility, additional gas vents were installed on the north, outer edge of the access road (seen above). It was stated (S. King) that waste was encountered during the installation of several gas vents, confirming that the EOW extends beyond current site map

boundaries. In the LFG Assessment and Remediation Plan (September 2010), the County stated that, as part of the Assessment Plan, *Haywood County will perform limited excavation to attempt to define the limits of waste along the northern and eastern portions of the landfill. Once the limit of waste is determined, the points will be surveyed and placed on a revised Overall Site Plan of the facility.* Note that the Francis Farm Landfill was operational in the early 1970's and that limited documentation exists to clarify the historical EOW.
