Heather Gregory: Investigation of a Slow-Moving Landslide: Hunter's Crossing Subdivision Waynesville, NC

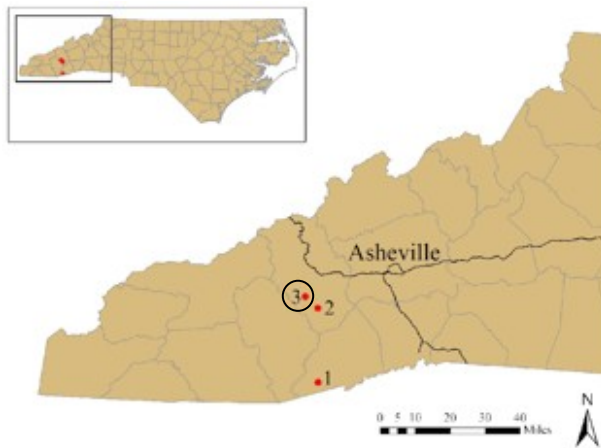
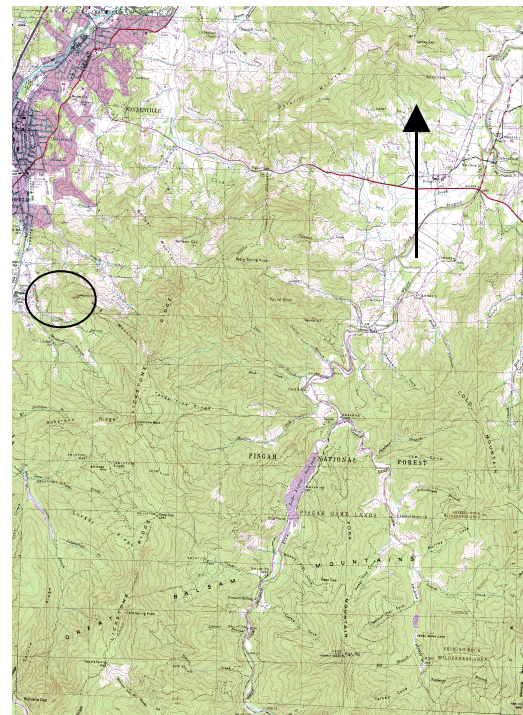
Figure 1

Hunter's Crossing Subdivision is located in Waynesville, NC. Figure one shows the approximate location of the Hunter's Crossing area. The picture on the left represents the western part of North Carolina, where the Hunter's Crossing area is denoted by the number 3. The other numbers are the locations of other "big slow movers" in North Carolina. The picture on the right is the approximate location of the Hunter's Crossing area on a map of the Waynesville area. It is located just outside the town of Waynesville, off of Lickstone Road, near Allen's Creek. (Alpha) December, 2006, North Carolina Geological Survey

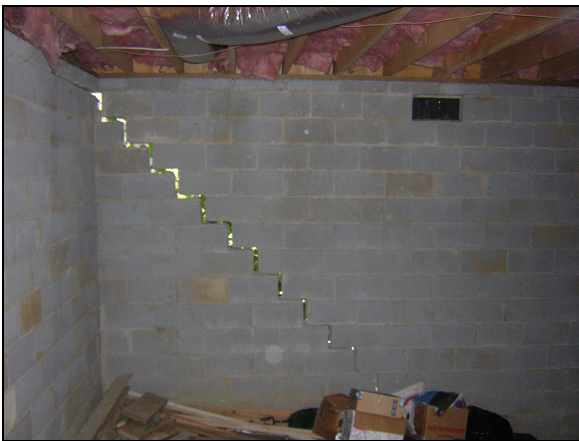
Figure 4

In 2001, the Hunter's Crossing community was constructed. In 2003, the first waterline ruptured due to the movement of the slope. In 2004, hurricanes Ivan and Frances swept through the area and dropped approximately 11 inches of rain on the area over 10 days. In 2005 the first damage was noticed and reported by the Hunter's Crossing residents. The second waterline rupture occurred, causing the water record to jump to 25,600 gallons. This is a large amount of water to be pumped into the sediments, possibly causing more instability, but that is unable to be proven at this time. The town of Waynesville shut off the utilities to the residences and forced the residents to vacate their properties. Figure 3 shows a sheared waterline at the toe of the slope and figure 4 shows damage to the foundation of a residence on the slope. Figure 5 shows damage to a carport on the slope, where the slope has pushed the carport so that it is leaning at an angle, and the beam has now become detached from the roof.

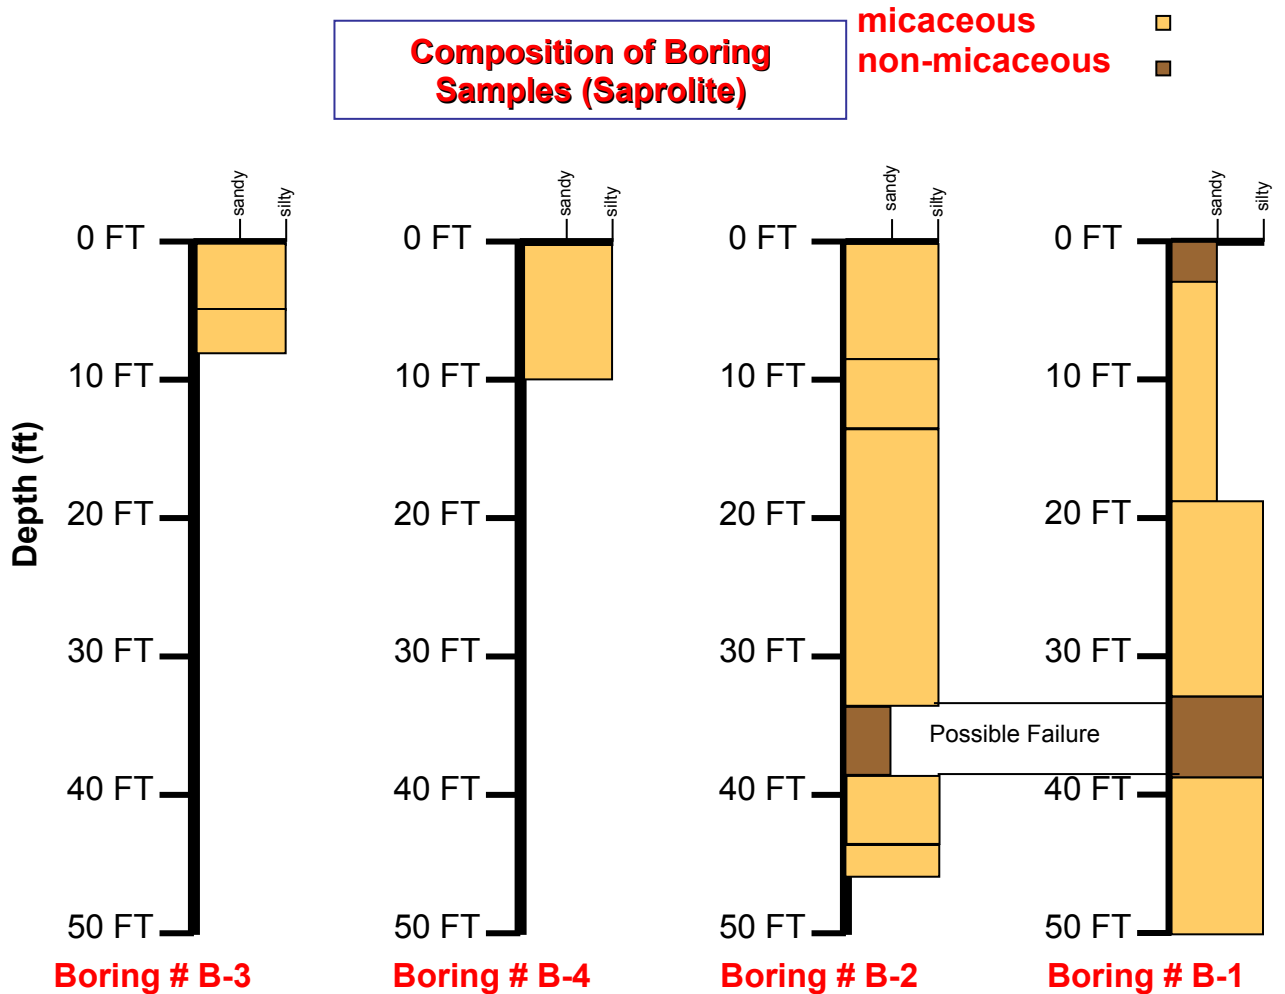
The bore holes provided a basis for determining the instability of the slope. The properties of the soils were mainly micaceous silty sands, and sandy sediments are less stable to build. This is primarily because sand is permeable, and during a storm event the rain could increase the pore pressure in the sediment, leading to more unstable conditions and possible failure of the surface. With the sediment that Alpha Environmental Services, Inc. analyzed being very sandy, that would result in the slope being less stable. Figure 12 illustrates the results of Alpha's bore hole samples. Note that the only possible failure surface is recorded in bore holes B-1 and B-2 at approximately 35 feet, in which there is an abrupt change in sediments, going from micaceous to non-micaceous sediment. This could be a possible failure surface because the sediment could be less permeable which

could cause water to pool on the surface, creating a failure surface. At this time, this is the only possible failure surface that has been identified. (Alpha) December, 2006, North Carolina Geological Survey

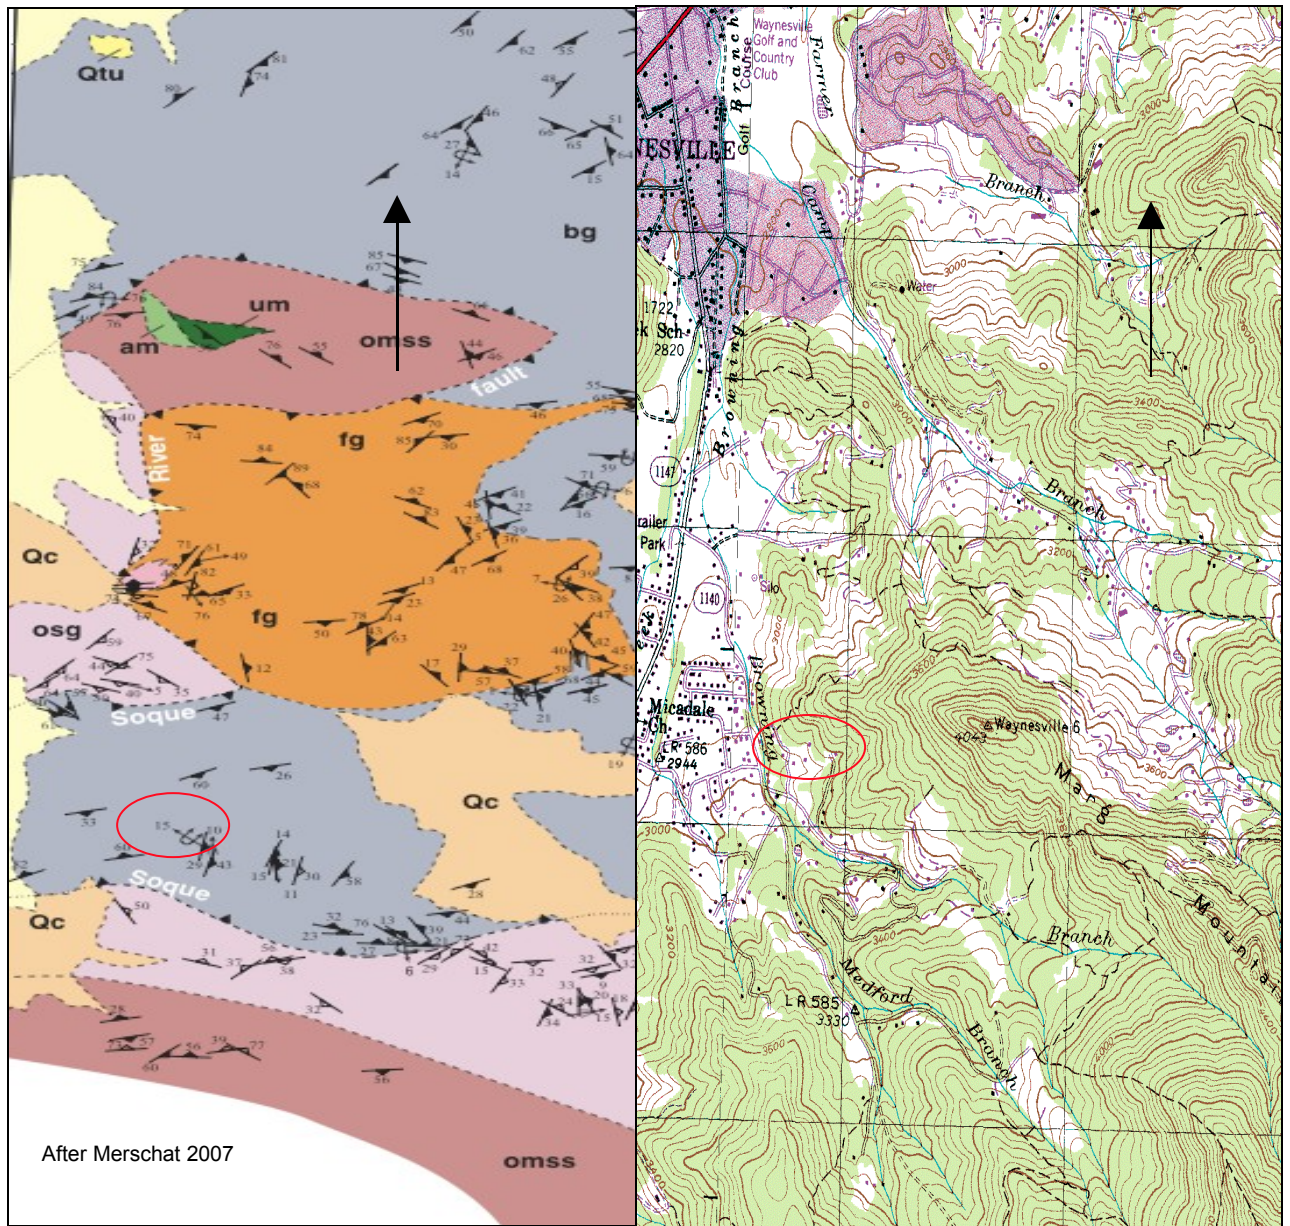
Figure 22

A lithologic description of the Hunter's Crossing area is given in figure 22. It is made up of mainly migmatitic biotite gneiss. Migmatitic biotite gneiss is medium to dark gray, consisting of dark-colored layers of medium-to coarse-grained inequigranular hornblende, garnet, biotite, quartz, plagioclase, biotite schist, and light colored, medium-to coarse-grained, granoblastic, biotite, quartz, feldspar rich layers. Stromatic migmatitic layering ranges from 1-70cm. Contains lens and layers of medium-grained amphibolite, garnet amphibolite, and biotite granitic gneiss. Layering is often intricately folded and may have a wavy appearance. This type of lithology is common for the Western North Carolina Area. The red circles denote the Hunter's Crossing area with respect to Western North Carolina. (Alpha) December, 2006, North Carolina Geological Survey
